ASBESTOS INSPECTION AND MANAGEMENT PLAN REPORT

Federal Building

8930 Ward Parkway
Kansas City, MO

October 7, 2010

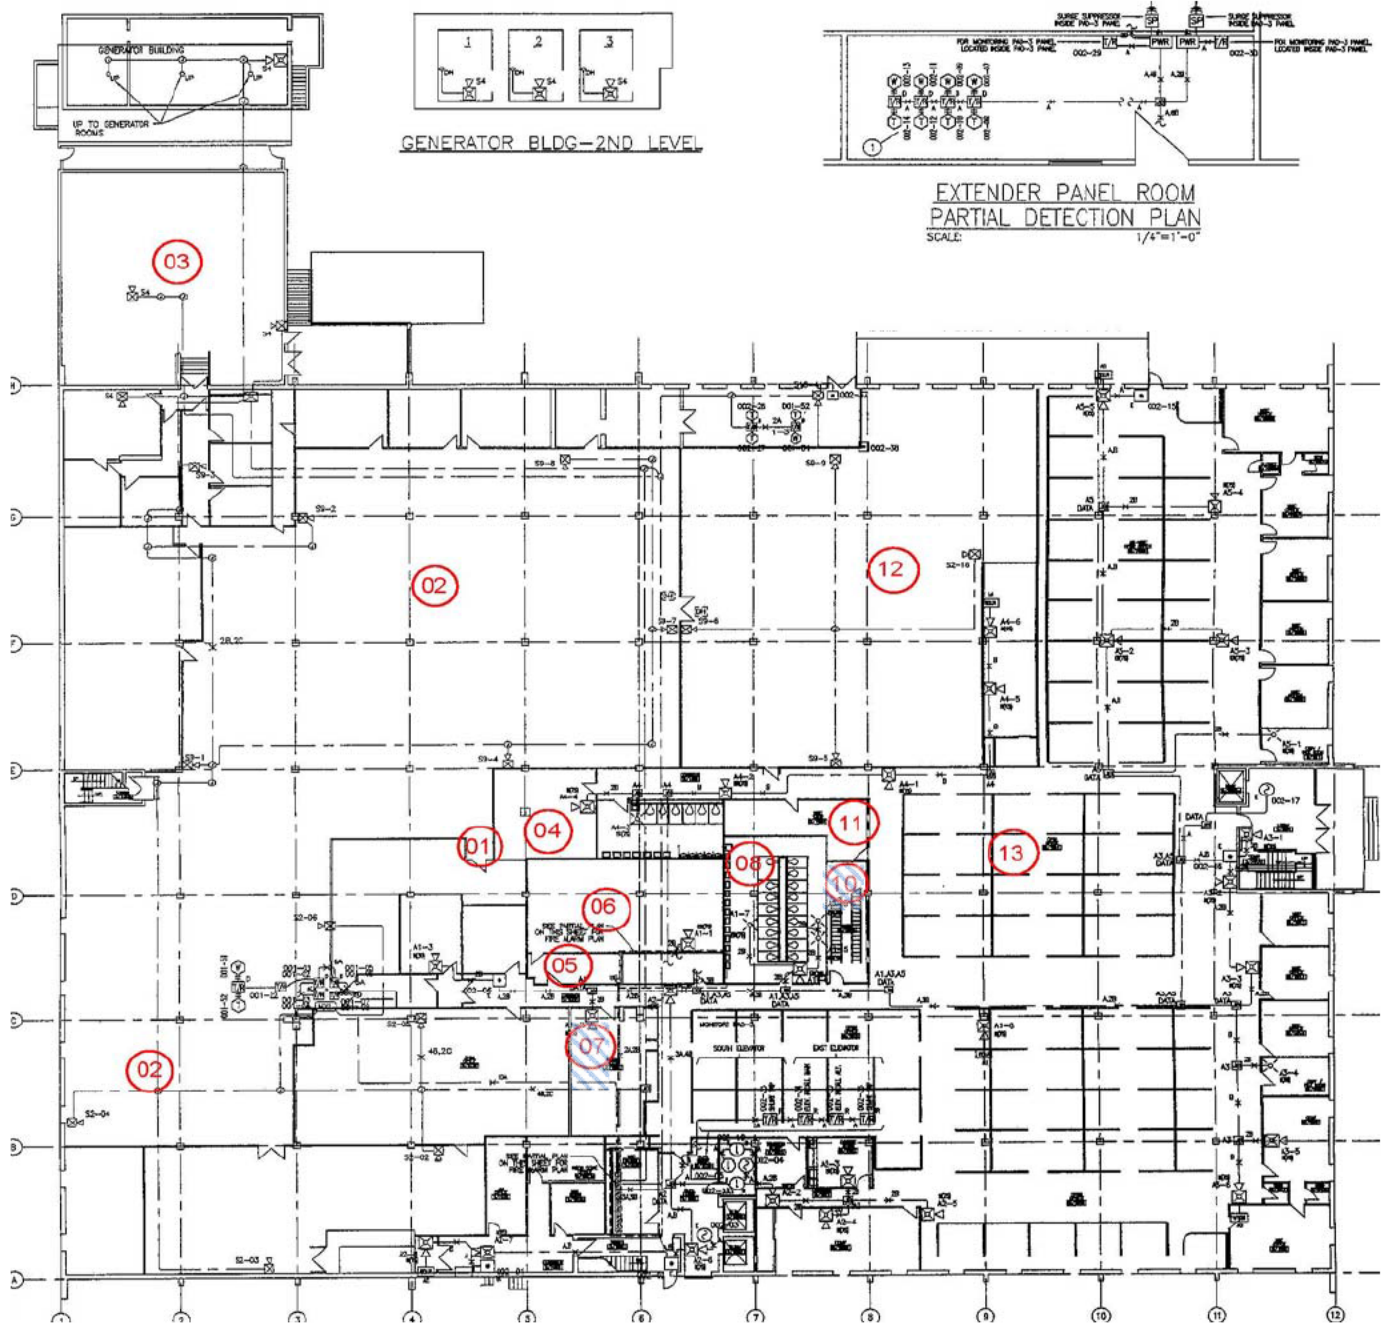
Asbestos Locations - First Floor

Fire Door (Assumed)

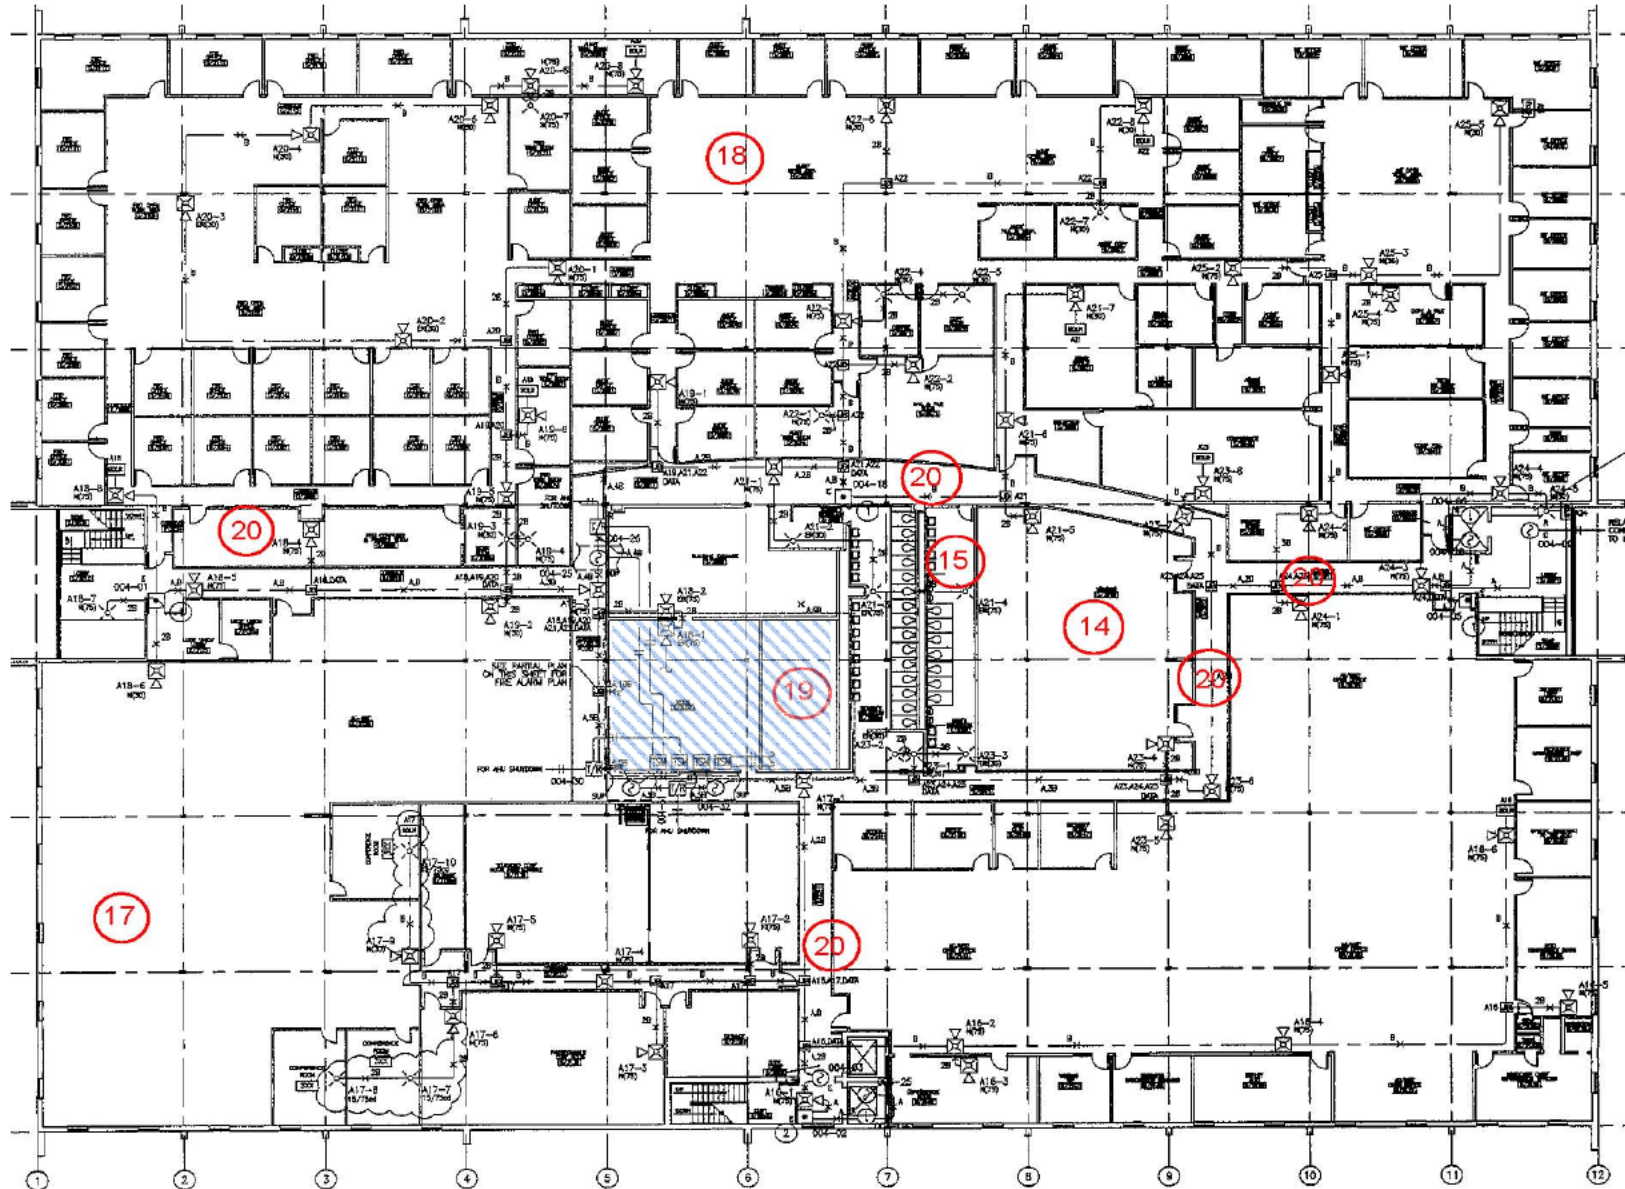
Asbestos Locations - Third Floor

Fire Door (Assumed)
